A minerals research contract report June 1982

DEMONSTRATING THE NOISE CONTROL OF A COAL PREPARATION PLANT VOLUME II:

LONG TERM TREATMENT EVALUATION

Contract H0155155 Bolt Beranek and Newman Inc. 10 Moulton Street Cambridge, MA 02238

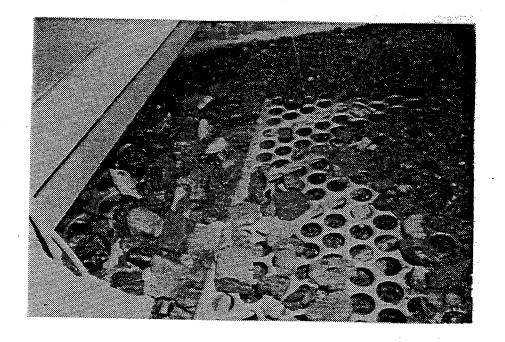
Although this test panel did not suffer from the delamination problems of the original "clad" decks, these panels did exhibit significant blinding (Fig. 11). The blinding, estimated by plant personnel to be 40-50%, was attributed to the thickness and resiliency of the panel. It should, of course, be noted that blinding potential is worse on these older crank-arm shakers

FIG. 11. PRIMARY SHAKER SCREEN (LEFT-HAND SCREEN PANEL IS GOODRICH MATERIAL, RIGHT-HAND PANEL IS STEEL).

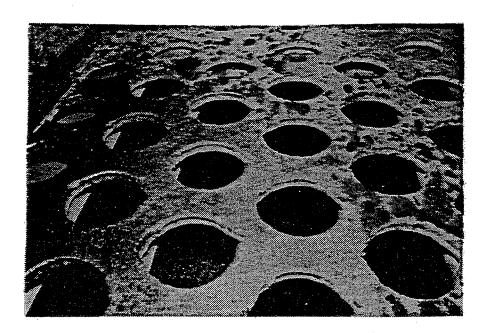
FIG. 12. GOODRICH MATERIAL ON PRIMARY SHAKER AS OF JULY 1979 (6 MONTHS AFTER INSTALLATION).

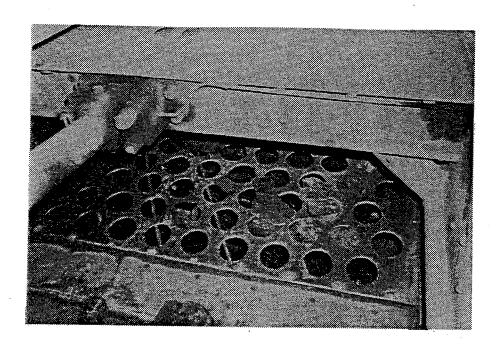
the June 1980 plant visit. Not only was this visible (see Fig. 13) but there was a distinctive sound generated by the impacts of the coal and rock as it dropped from one level on the shaker to the next lower level where the Armaplate was worn out. Although severely worn, it should be noted that these impact pads were in use for over three years.

FIG. 13. WORN-OUT 1/2 IN. ARMAPLATE IMPACT PAD AT DISCHARGE OF PRIMARY SHAKER (AFTER 3 YEARS OF SERVICE).

months. The original pad was replaced with a 1-1/2 in. thick urethane pad which was at least as effective in reducing the impacts and provided significantly improved service life. Figures 14 and 15 show the pad shortly after installation (Nov. 1976) and after 1-1/2 years of service (July 1978). The pad eventually provided in excess of 2 years of service before requiring replacement.

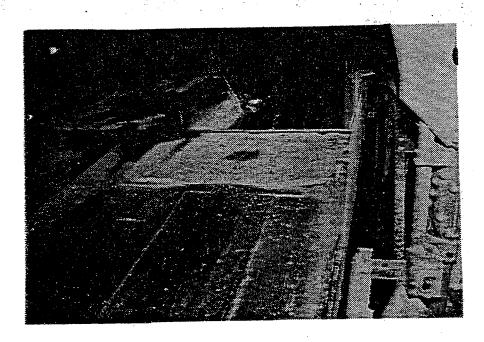
FIG. 15. URETHANE IMPACT PAD ON PICKING TABLE AFTER 1-1/2 YEARS OF SERVICE (JULY 1978).

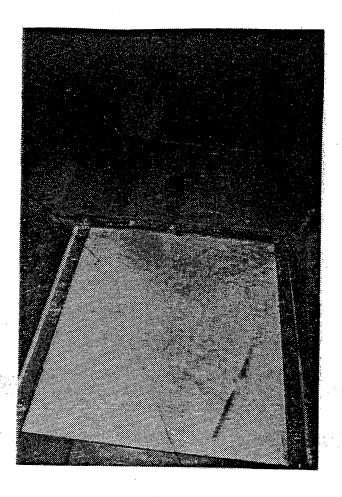
The last material experimented with on this table was B.F. Goodrich's Linerite (see Fig. 16). This material was installed (with the UHMW plastic layer facing up) downstream of the above mentioned urethane impact pad to determine if this material would be effective in reducing the "rumble" from coal and rock moving across the table. Although the material provided a suitable table surface allowing proper material flow, it wore relatively quickly. It was installed in June 1979 and was worn out by December 1979.

FIG. 16. B.F. GOODRICH LINERITE (UHMW SIDE UP) INSTALLED BELOW URETHANE IMPACT PAD ON PICKING TABLE.

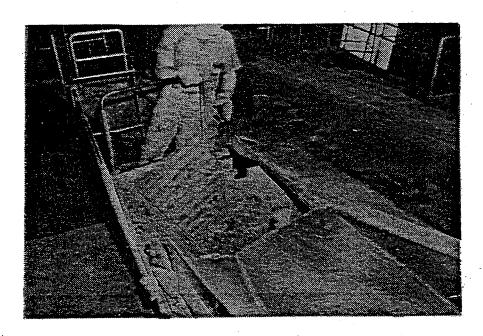
Two resilient pads were installed in the crusher infeed chute in 1976 to reduce the impact noise generated by large rocks falling into the open chute. The pads, which were 2-3/16 in. profiled Trelleborg rubber, were very effective in reducing these impacts. The profiled surface was selected to achieve a near 90° impact angle which is optimum for long service life. The pads turned out to be extremely durable, and were still quite serviceable after more than three years of operation (see Fig. 17).

FIG. 17. PROFILED TRELLEBORG IN INFEED TO MCLANAHAN CRUSHER (AFTER 3 YEARS OF SERVICE).

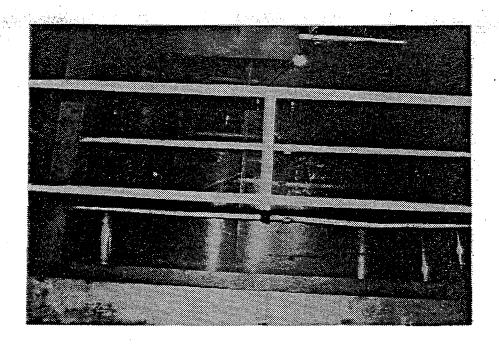
FIG. 18. CLEAR VINYL CURTAIN PANELS AT DISCHARGE OF SECONDARY SHAKERS.

and closed without difficulty. The clear vinyl panels, however, did not provide the desired visual access over the long-term due to a buildup of dirt. Plant personnel also reported that they had a tendency to stiffen during cold weather, making them difficult to open.

For future curtain installations it is recommended that the use of a 12 in. overlap and double rows of Velcro fastening strips at each openable seam would make the system more convenient and ensure a positive seal even when not closed carefully.

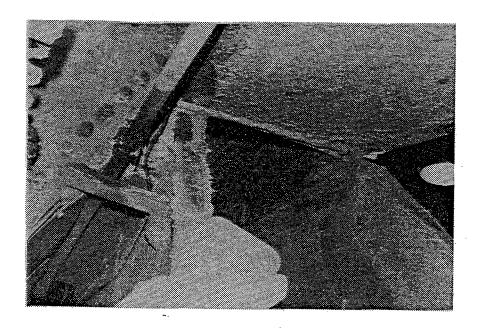
FIG. 19. PROFILED TRELLEBORG IMPACT PADS IN DISCHARGE OF JIG ELEVATORS (AFTER 2 YEARS OF SERVICE).

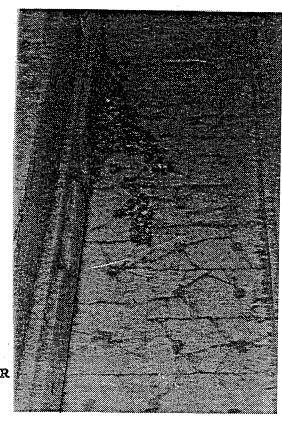
FIG. 20. CERAMIC TILE CHUTE LINER IN NO. 2 JIG DISCHARGE CHUTE (NOTE CRACKING OF TILES).

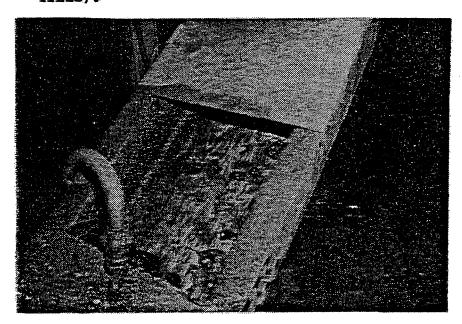
FIG. 21. CERAMIC TILE CHUTE LINER IN NO. 2 JIG REFUSE CHUTE AFTER MORE THAN 3 YEARS OF SERVICE.

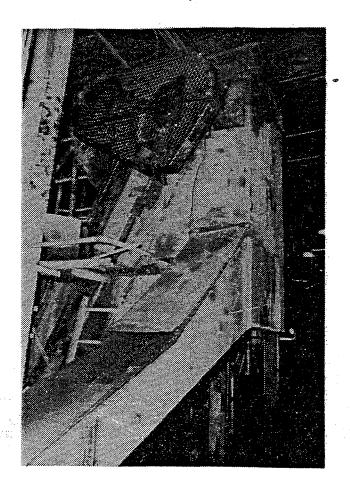
In general, the covers over the jig elevators and chutes were effective and durable. The covers were not, however, consistently replaced after maintenance and inspection as can be seen in Fig. 22.

FIG. 22. REFUSE CHUTE ON NO. 2 JIG ELEVATOR.

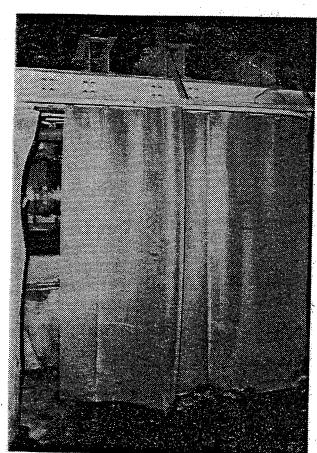
These curtains were replaced with smooth loaded-vinyl curtain: similar to those used on the secondary screens (including a civinyl panel at the screen discharge). As was the case for the secondary screen installation, the plain loaded-vinyl curtains performed satisfactorily, but the clear panel became obscured with dirt (see Figs. 23 and 24) and stiff in the cold weather.

FIG. 24. DIRT BUILDUP ON CLEAR VINYL CURTAINS AT DISCHARGE OF MIDDLING SCREENS (JUNE 1980).

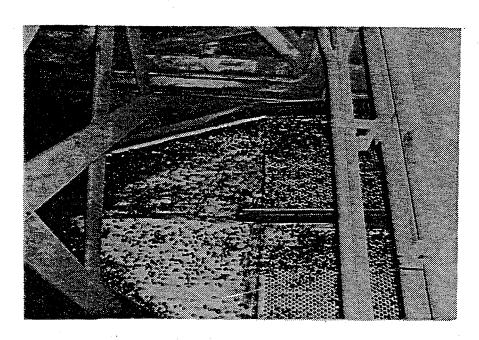
The 1/2 in. thick UHMW plastic was originally installed j both the discharge chutes and the receiving hoppers in Septemi 1976. After 5 months of service, the plastic in the receiving hoppers began to exhibit worn patches and was considered worn after 14 months. This experience was similar to that for the refuse chutes, again indicating that the UHMW plastic was not suitable for impact-type flows. The material flow at the scredischarges, on the other hand, is relatively smooth and unifor and in this application the plastic chute liner proved to be a durable (Fig. 25). As of June 1980, almost 4 years after the initial installation, the plant reported that only the tail pronounce of the placed.

FIG. 25. UHMW IN CLEAN COAL DESANDING SCREENS AFTER ALMOST 4 YEARS OF SERVICE (JUNE 1980).

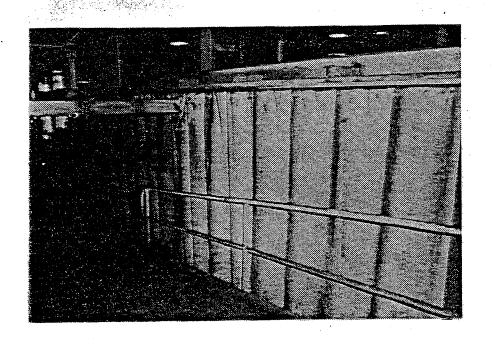
The smooth loaded-vinyl curtains were installed in Septer 1976 and, as can be seen in Fig. 26, were still in good condition as of June 1980.

FIG. 26. LOADED-VINYL CURTAINS AROUND CLEAN COAL DESANDING SHAKERS AFTER ALMOST 4 YEARS OF SERVICE (JUNE 1980).

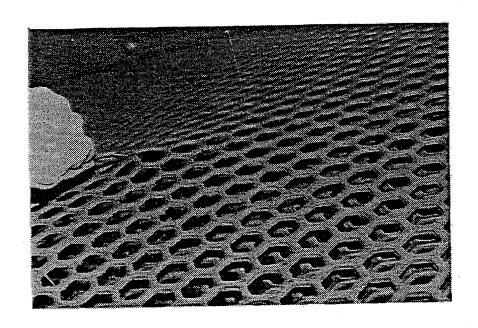
The resilient screen decks evaluated in this area consisted of a 1/4 in. thick Tuffgard-brand polyurethane top surface coldbonded to a 3/16 in. punch plate, and had 1-1/8 in. hexagonal holes. After approximately 7 months of service the urethane layer on one of the vibrators had completely separated from the steel backing (see Fig. 27). This separation was judged "premature" since the elastomer, although separated from the steel, did not exhibit significant wear. This indicated that the elastomer-clad screen deck life would have been significantly longer if it weren't for this apparent failure of the bond between the urethane and the steel.

FIG. 27. DELAMINATION OF URETHANE LAYER ON RIPL-FLO* SCREENS.

Since this problem was not previously reported in the literature, a separate study was undertaken to investigate whether the conditions present in the Georgetown Plant were uniquely unsuitable for these screen decks or if the problem was inherent in some of the products. As part of this study, several types of elastomer-clad screen decks from two screen perforating companies were installed in four different coal preparation plants for further evaluation. The details of this study are discussed in Sec. 3 of this report.

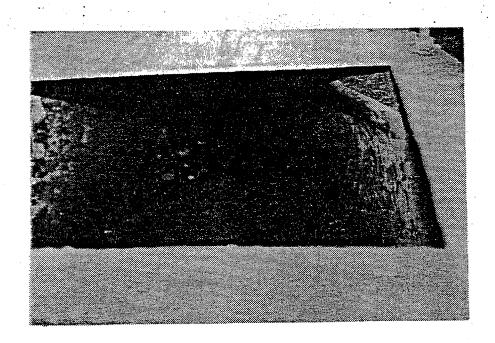
The discharge chutes for four of the Ripl-Flo* screens (Nos. 3, 4, 5, and 6) were lined with rubber between December 1976 and January 1977. The materials proved to be quite durable with no reported problems other than some difficulty in one of the chutes with coal pushing between the rubber layer and the steel chute wall (see Fig. 28). This can be minimized by more careful orientation and protection of the seams during fabrication.

FIG. 28. RUBBER LINER IN RIPL-FLO® DISCHARGE CHUTE (NOTE BULG)
PRODUCED BY COAL PUSHING UNDER RUBBER LAYER - UPPER
RIGHT-HAND CORNER OF PHOTO).

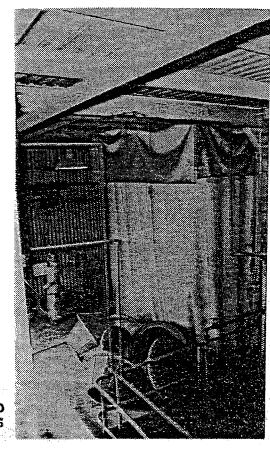
FIG. 29. CURTAINS AROUND REINVELD DRYERS AFTER 3-1/2 YEARS OF SERVICE.

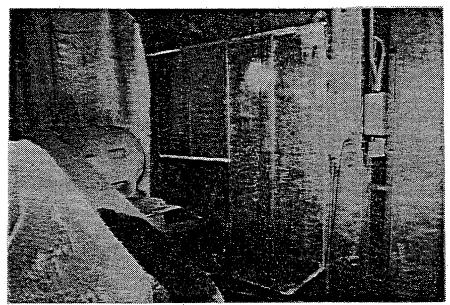
Curtains were used around both the Reinveld and Wemco dryers. In both installations the curtains (loaded-vinyl with sewn-on Velcro fasteners) proved to be durable as well as effective. The curtains were installed around the Wemco dryers in April 1975 and the Reinveld dryers in November 1976. As of June 1980 both installations were functioning and in good condition. Figure 29 shows the curtains around the Reinveld dryers. The only repairs reported by the plant during this period were replacement of several of the stationary panels (behind the end dryer) which had become torn. These panels were replaced with fixed steel panels in 1979 (Fig. 30).

FIG. 30. ACOUSTICAL PANELS INSTALLED BEHIND END REINVELD DRYET TO REPLACE REAR CURTAIN PANELS (SEE TEXT).

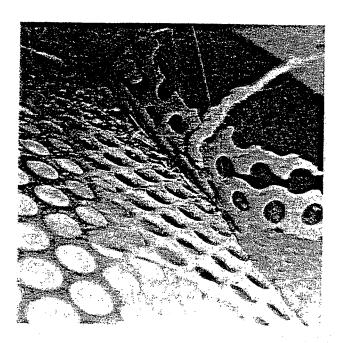
FIG. 45. TYPICAL ABRASIVE WEAR PATTERN OF ELASTOMER-CLAD SCREEN DECKS.

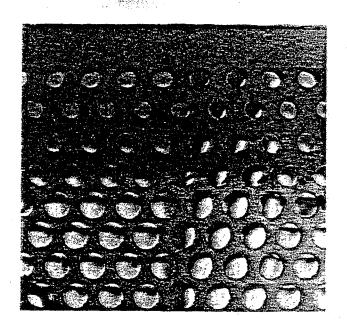
FIG. 46. TYPICAL ABRASIVE WEAR PATTERN ON ELASTOMER-CLAD SCREEN DECKS.

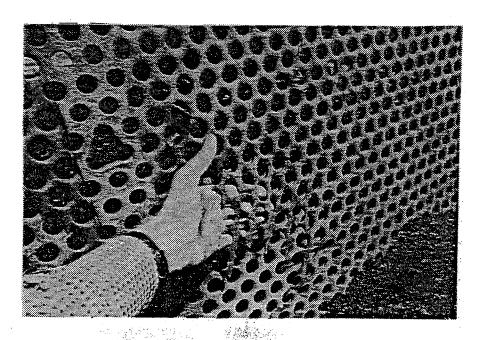
FIG. 55. RUBBER-CLAD FEED PANEL IN PLANT D AFTER 3-1/2 MONTHS OF SERVICE.

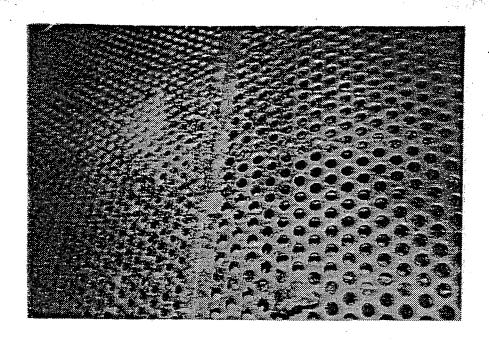
The urethane-clad panels, on the other hand, proved to be extremely durable. Figure 56 shows the urethane-clad feed panel after 3-1/2 months of service (taken at the same time as Fig. 55 for the rubber-clad panels). At the end of 6 months, only a slight hole elongation was evident on the urethane-clad panels. After 14 months of service, the two urethane-clad discharge panels were installed on the feed end of screen B (from which the rubber-clad panels were removed). The urethane-clad panels were eventually removed after 16 months because of cracking of the steel backing (rather than wear of the urethane top surface).

FIG. 56. URETHANE-CLAD FEED PANEL (RIGHT-HAND SIDE OF PHOTO) AFTER 3-1/2 MONTHS OF SERVICE.
